MASS MOVEMENT BELOW THE PARKWAY

IMPROVING COLUMBIA PARKWAY

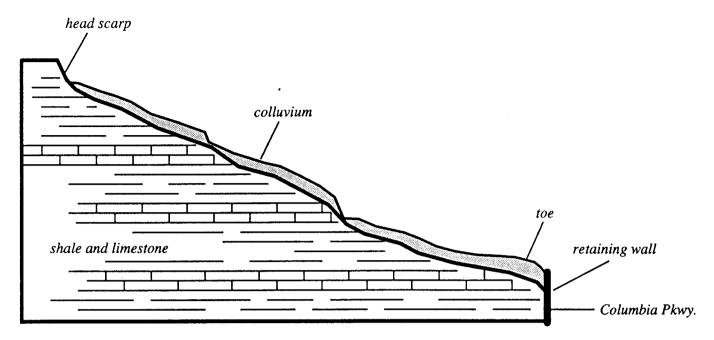
FIGURE 3.—Cross section through a typical thin colluvium landslide along the Ohio River valley. Bedrock is predominantly shale with limestone interbeds, and the landslide slip surface coincides with the bedrock-colluvium contact.

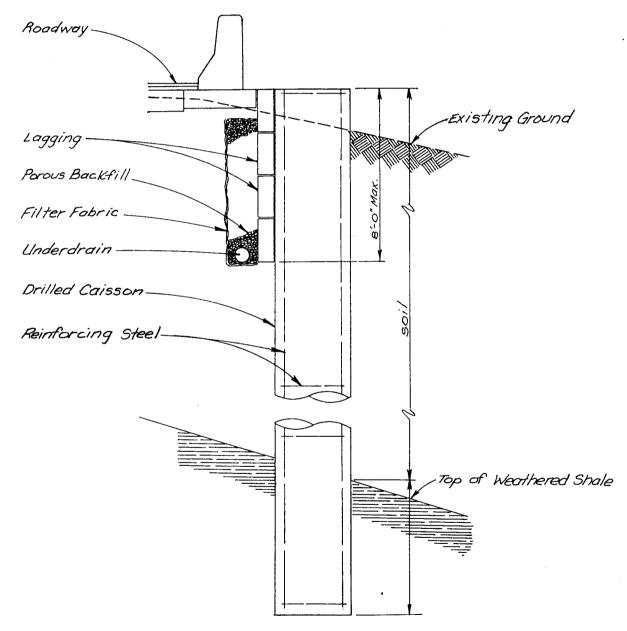
FIGURE 4.—Design of a typical cantilevered pier wall used to support potentially unstable slopes in the Cincinnati area. Pier walls are constructed by drilling large diameter holes into bedrock, which are in turn filled with reinforced concrete. When completed, each pier acts as a lever to prevent the colluvium from moving downslope.

Because of continuing sliding beneath the parkway and the need to further widen the roadway, the downhill side of the pavement along 5.2 miles of Columbia Parkway will be stabilized using 3.2 miles of drilled pier walls. A pier wall is an earth-retaining structure consisting of a row of individually drilled piers socketed into stable bedrock. The piers are constructed so that they penetrate the unstable soils and develop resistance to the lateral loads in the underlying bedrock. In many cases, the depth to bedrock is such that tiebacks with grouted rock anchors are necessary to support

the tops of the piers. Figures 4 and 5 show typical details of a cantilevered and tied-back drilled pier. The diameter of the piers on Columbia Parkway projects ranges from 30 to 48 inches, and the length ranges from 15 to 55 feet. The bedrock sockets range from 5 to 18 feet deep, and the total number of individual piers to be installed is 2,526. Estimated cost of the project is \$25 million, or about \$5 million per mile. While these projects will stabilize the parkway, they will neither eliminate landsliding below the pier walls

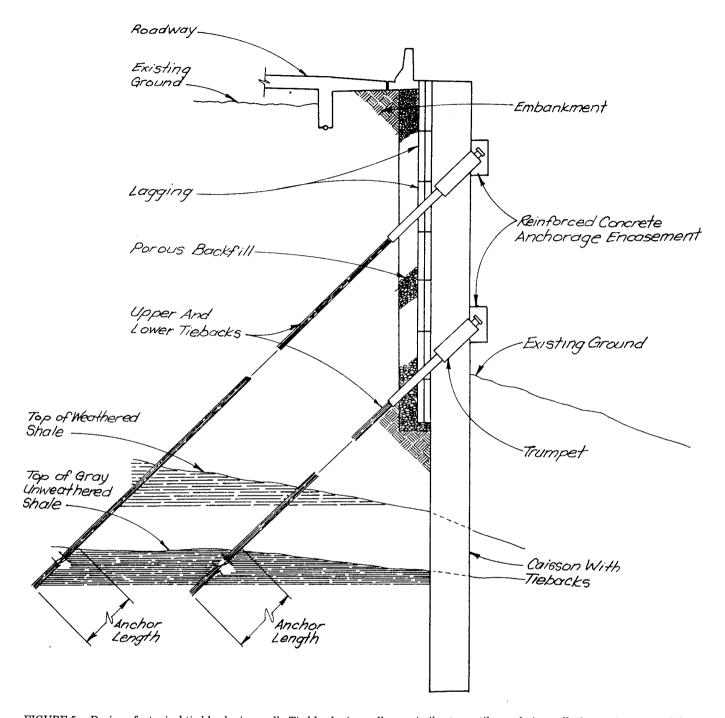
FIGURE 5.—Design of a typical tied-back pier wall. Tied-back pier walls are similar to cantilevered pier walls, but resistance to sliding is increased by adding steel tiebacks anchored in stable shale bedrock.
